Manhole Inspection Summary

Manhole # S67M__024MH

Insp Date: **1/22/08 1:15 PM**

Location Address: **6400 Bushey St.**

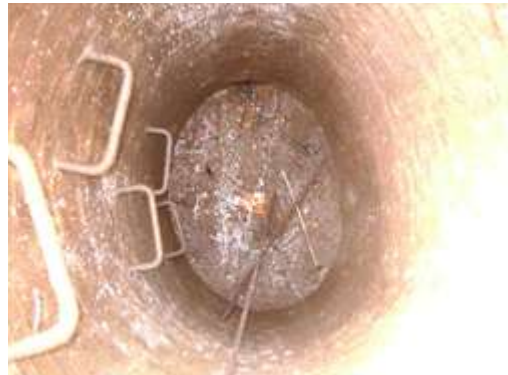
Top View

Comments **HEAVY DEBRIS IN TERMINAL MANHOLE.**

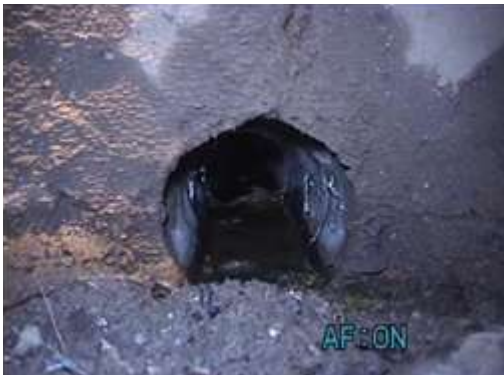
Channel

Condition: ☐ Sound ☐ Cracked ☐ Root Intrusion ☐ Deteriorated ☐ Leaks ☒ **Debris**

debris in channel--encrustation and grease

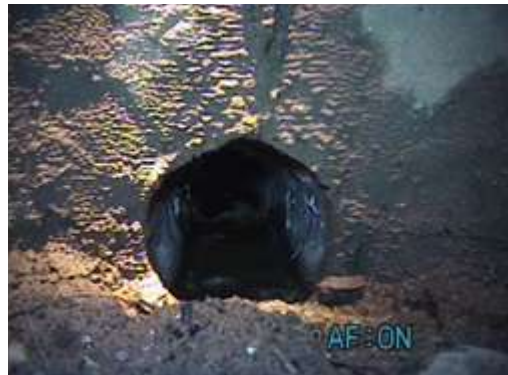
Defect 1

12 oclock outgoing pipe connection
ground water all around it

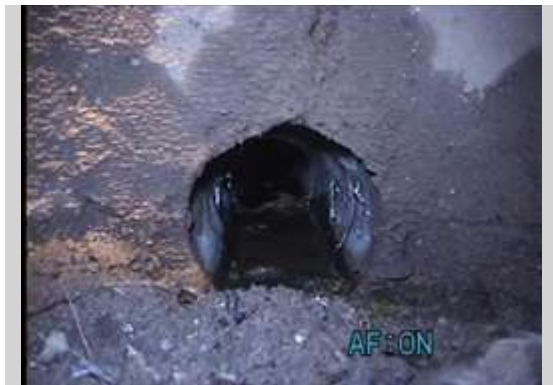
12 O'Clock Outflow

Deposits: ☐ None ☐ Mud ☒ **Gravy** ☒ **Debris** ☐ Grease

Silt Depth: **2** (in.) Deposits Extent: **Heavy**
